AIRCRAFT SERIOUS INCIDENT REPORT AND EXECUTIVE SUMMARY

Reference:	CA18/3/2/0806	
Aircraft Registration	ZS-PMY	Date of Incident	10/09/2010		Time of Incident	1245Z
Type of Aircraft	Cessna 172RG (Aeroplane)		Type of Operation		Private	
Pilot-in-command Licence Type		Commercial	Age	19	Licence Valid	Yes
Pilot-in-command Flying Experience		Total Flying Hours	246,2		Hours on Type	35,3
Last point of departure		Cape Town International Aerodrome (FACT)				
Next point of intended landing		Cape Town International Aerodrome (FACT)				
Location of the incident site with reference to easily defined geographical points (GPS readings if possible)						
Cape Town International Aerodrome, Taxiway Charlie						
Meteorological Information		Surface wind 135°/15 kt, temperature 17 °C, visibility +10 km				
Number of people on board	1 + 2	No. of people injured	0	No. of people killed	0	
Synopsis						
<p>The pilot, accompanied by two passengers, departed from Cape Town International Aerodrome on a local private flight. After being airborne for approximately one hour and forty-five minutes they returned to FACT for the landing.</p> <p>Prior to landing the pilot selected the landing gear down and normal ope

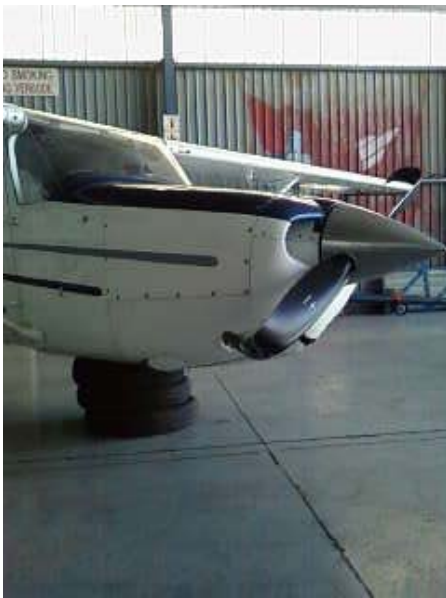
- 1.3.1 The aircraft sustained substantial damage when the nose landing gear collapsed.

Visible damage to the propeller

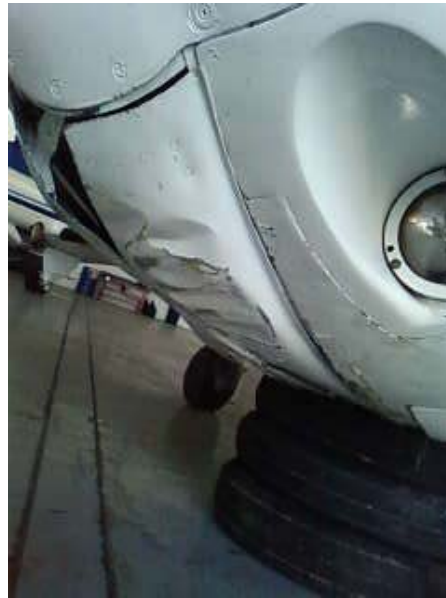
Visible damage to the nose gear doors

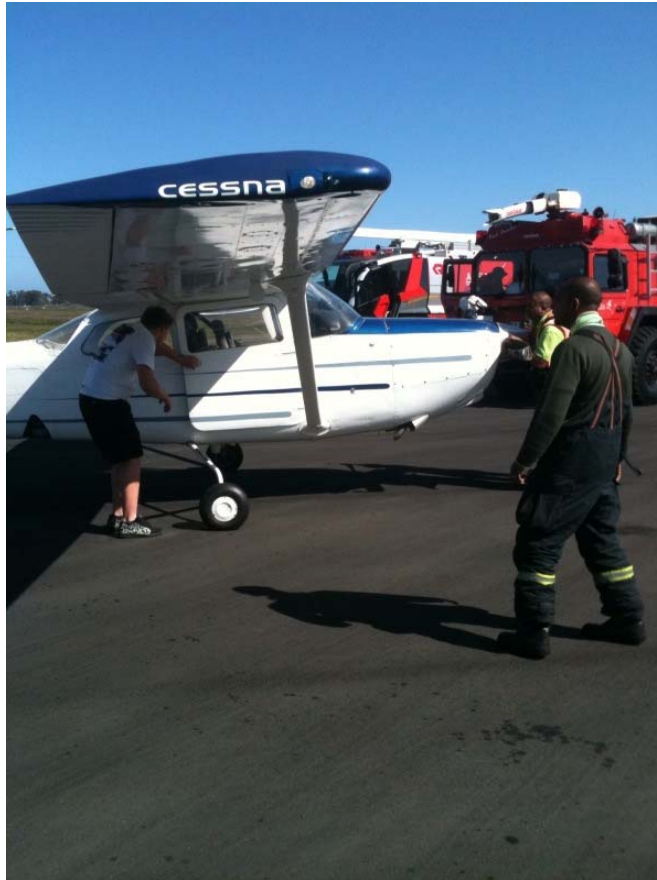
1.12.1 Following landing on runway 19, the pilot turned right onto taxiway Charlie to vacate the runway when the nose gear collapsed and the propeller struck the asphalt surface. The aircraft came to a halt in a nose-down attitude on the taxiway.

A photo of the aircraft being recovered with the nose gear retracted.

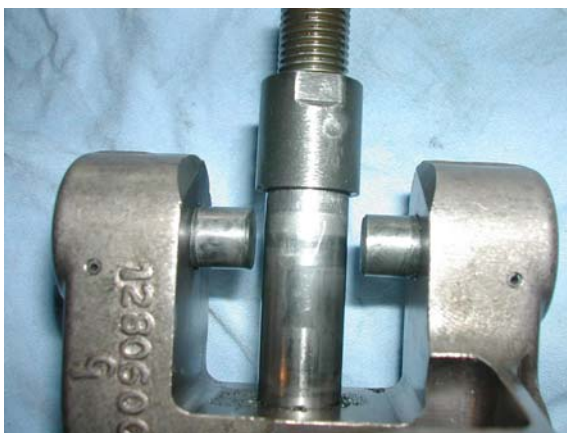
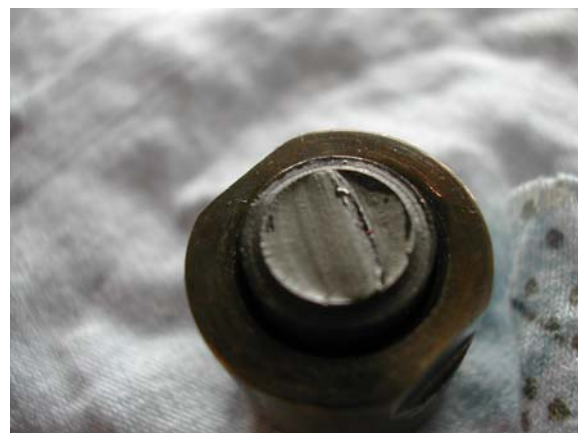
The landing gear safe light was tested and found serviceable. The audio warning system, although soft, was operational. Upon further inspection it was found that one of the NLG actuator down lock pins had shifted against the actuator shaft, preventing the locking mechanism from achieving its down lock position. On further inspection the nose landing gear down lock actuator pins were examined and one of the pins was found to have failed (see photo below) in fatigue, causing the nose landing gear not to lock down properly within the down lock hook mechanism.

A view of the actuator with the down lock pins installed. A view of the failed down lock pin contained in the housing.

- 2.3 The down lock pins on the nose landing gear actuator are on-condition items, and if not properly inspected/maintained they might fail in operation without prior notice. Although this aircraft was subjected to a maintenance inspection shortly prior to this failure and only 7 flying hours were recorded, it is considered highly unlikely that the fatigue cracking that might have been present at the time would have been picked up by maintenance personnel, as it was not a schedule inspection requirement to inspect these pins for cracks nor to have them subjected to any form of non-destructive crack testing procedure during maintenance. The pin was found to have failed in fatigue.

3.2.1 The nose landing gear (NLG) collapsed following touchdown due to the failure of one of the NLG actuator down lock pins.

4.1 It is recommended that the Director of Civil Aviation in collaboration with the Airworthiness Division introduce a life limit or non destructive test procedure at regular intervals on the down lock pins to ensure that safety is not compromised and to prevent a re-occurrence of this nature.
